THE CLOCK OF ST. PETER'S CHURCH, STOKE FLEMING.

John A. Dietz.

July 2014.

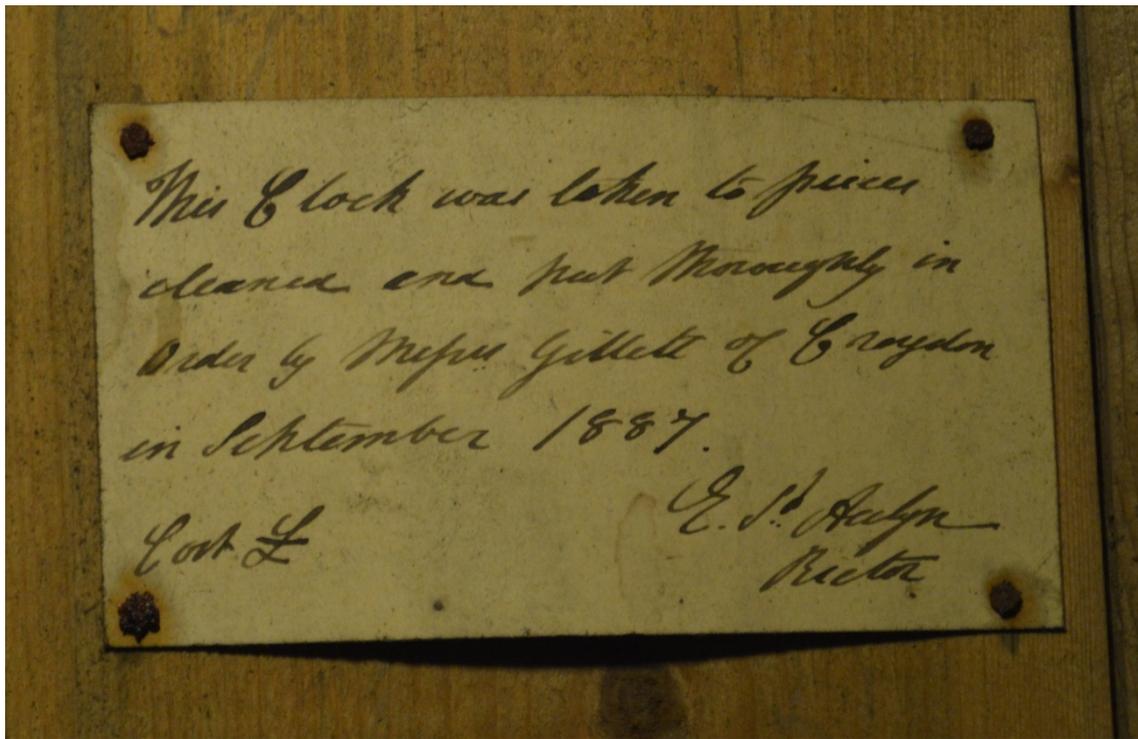
*“This clock was taken to pieces
cleaned and put thoroughly in
order by Messrs Gillett of Croydon
in September 1887.*

The card from 1887 pinned to the inside of the clock case.

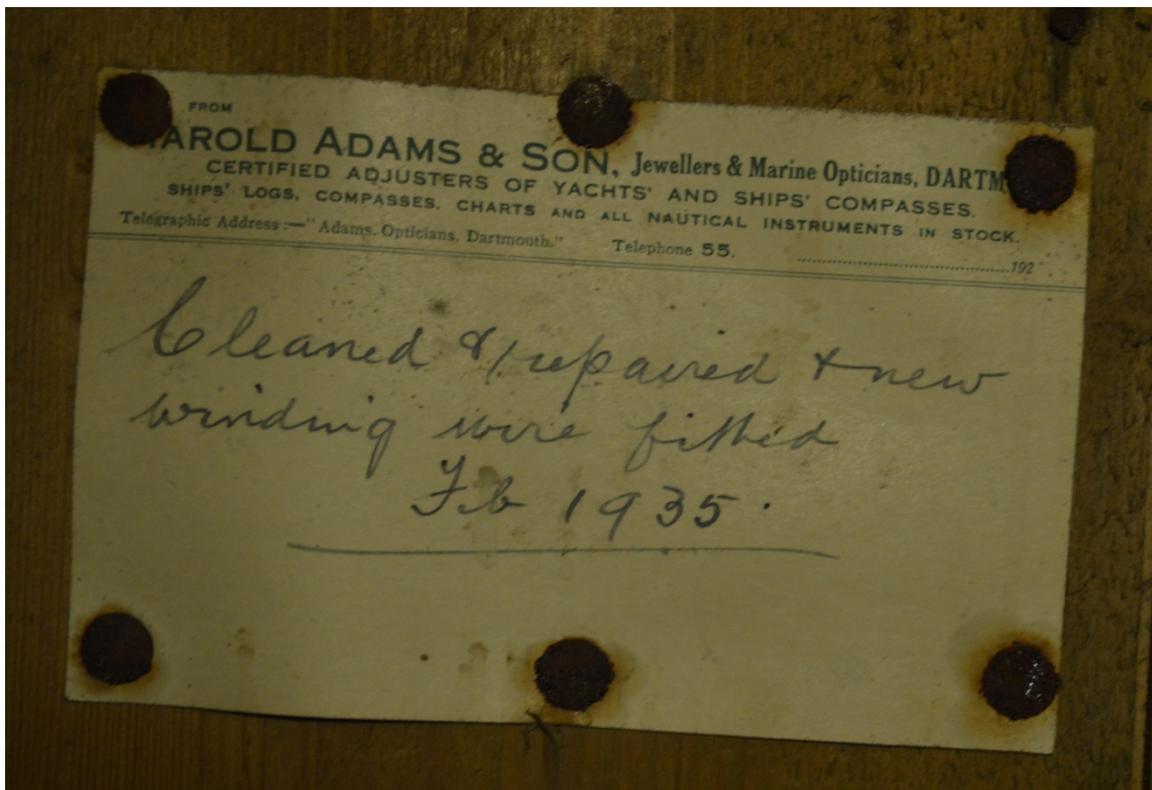
On the face of it, the comment in the notes is perhaps a little unfair on the clock, considering that the work carried out should have been little more than routine maintenance. The weight lines (winding wires) last quite well but are bound to require periodic replacement. On this occasion it seems, the replacement was not carried out until after the wire had failed.

Card left by Harold Adams & Son after the repair of the winding wire in 1935.

*"Cleaned & repaired & new winding wire fitted.
Feb 1935.*

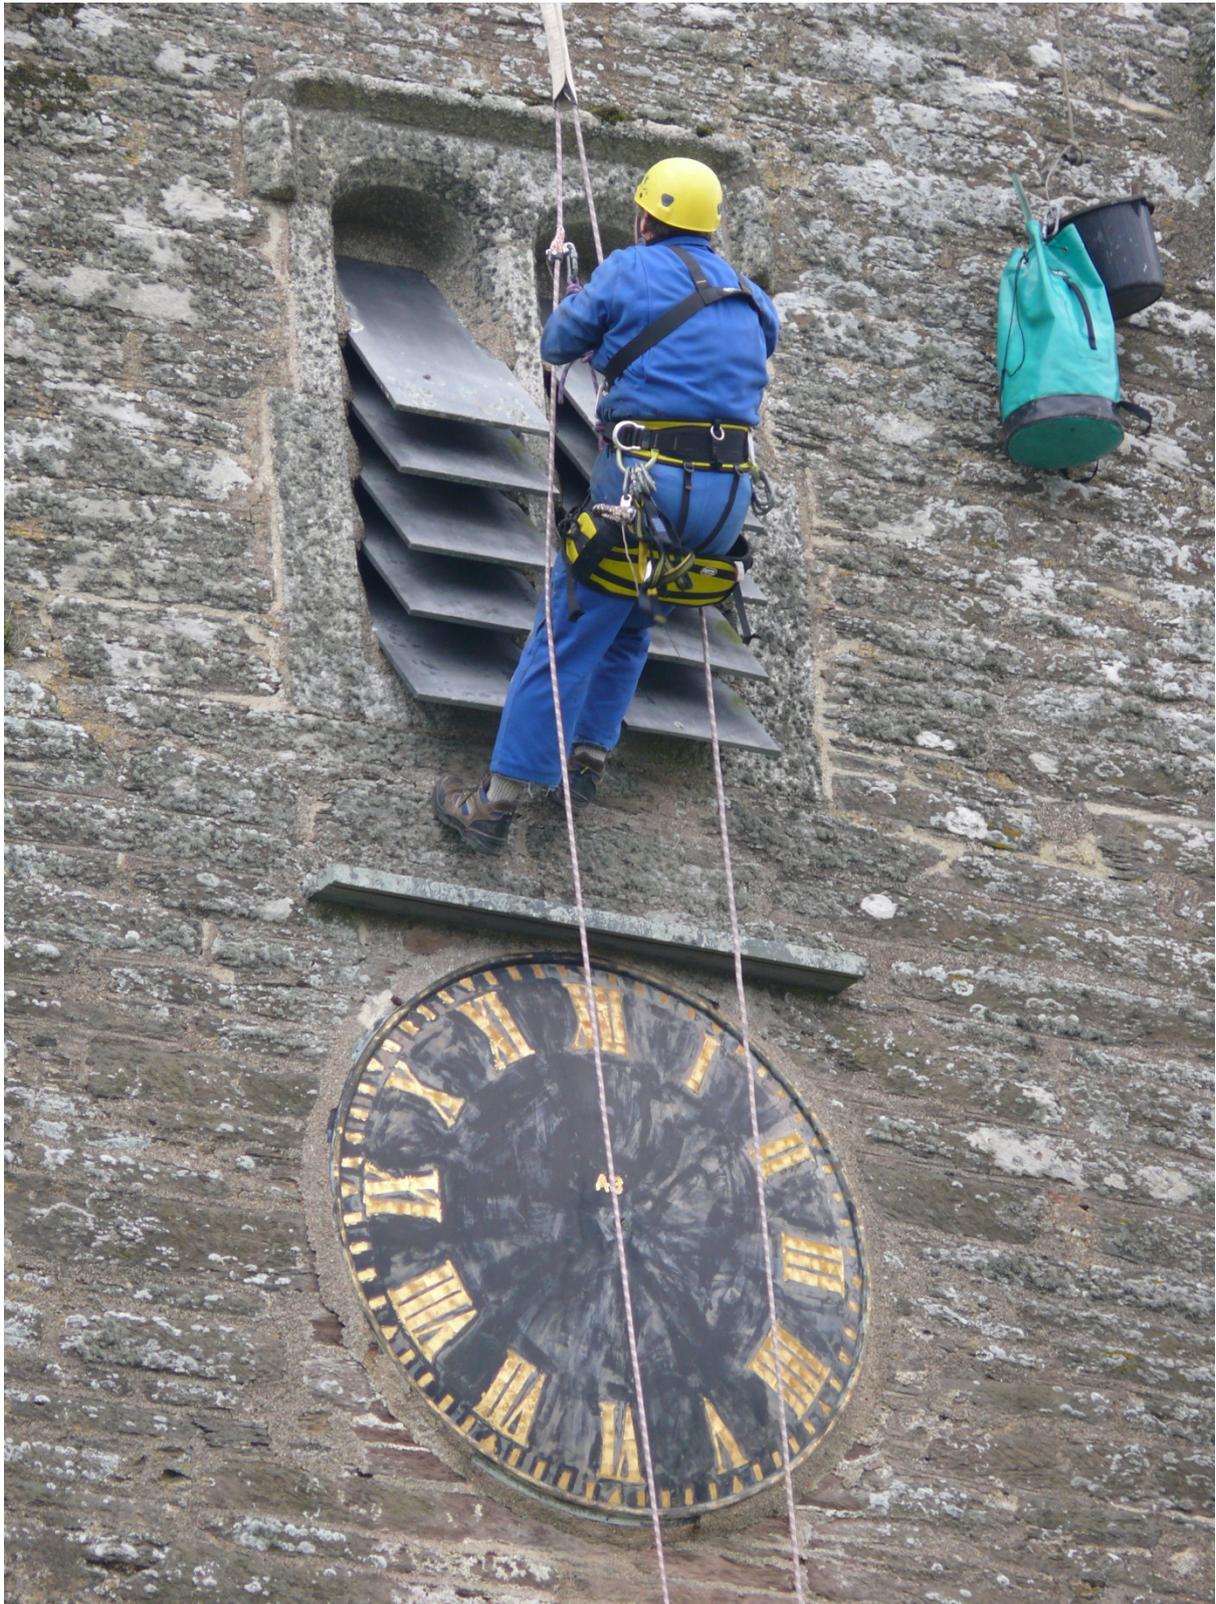
Eventually Smith of Derby were asked to investigate and the problem was traced to the dial drive shafts where they pass through the east wall to the dial. At this point the dial drive is converted by gearing into two separate shafts, one for each hand, with one shaft in the form of a tube and the other a rod inside it. Dirt had accumulated inside the tube and was causing the inner shaft to bind against it.

Repairing the clock in 2008.

In January 2008 the hands and drive shafts were removed, the shafts cleaned and greased, and everything replaced. Again the work was carried out by abseiling down from the top of the tower.

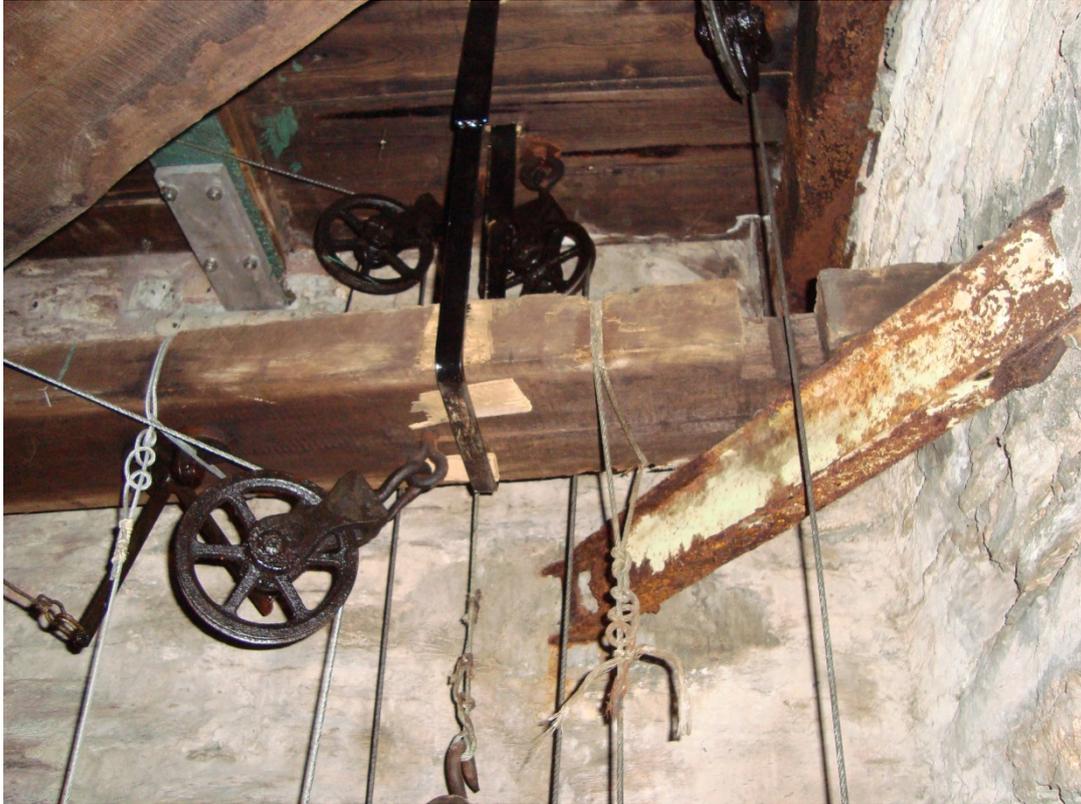
The weights which drive the clock are suspended from wires which are fixed to a wooden beam in the north-west corner of the tower, and to the floor of the bell chamber above. One end of the wooden beam is embedded in the tower wall and in 1964 it was found to be decayed. The chosen remedy was to support it with a steel girder placed diagonally across the corner.

The steel girder has itself steadily corroded over the years and in early 2013, during investigations into the bell frame, it was found that this girder also had holes through the webbing where it was embedded in the stonework. It was felt that there was a real risk of it

failing, possibly while the clock was being wound, which could have resulted in the weights falling and the clock winder being injured by the wires.

The girder which was installed in 1964 to support the beam carrying the weights. A hole is clearly visible in one end of it.

In view of all this, it is proposed to include in the scheme to rehang the bells the conversion of the clock to electric auto-winding. That will avoid the cost of replacing the corroded girder supporting the weights and repairing the weight line pulleys, and overcome the need to find volunteers in the future to carry out the manual winding.

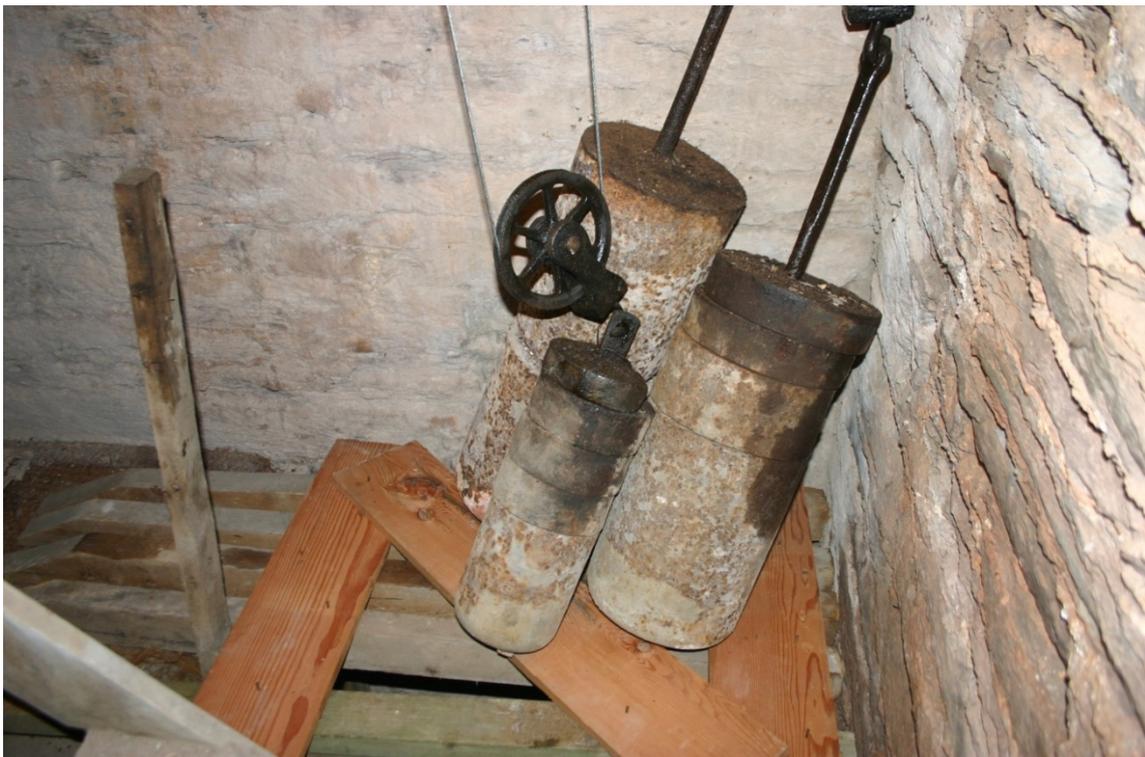
The clock weights temporarily supported at clock chamber floor level. January 2013.

In January the weights were lowered for safety and removed to the windowsill of the ringing chamber, a convenient and firm platform on which to rest them. This action of course resulted in the clock being stopped, which promptly brought a round of enquiries from the villagers.

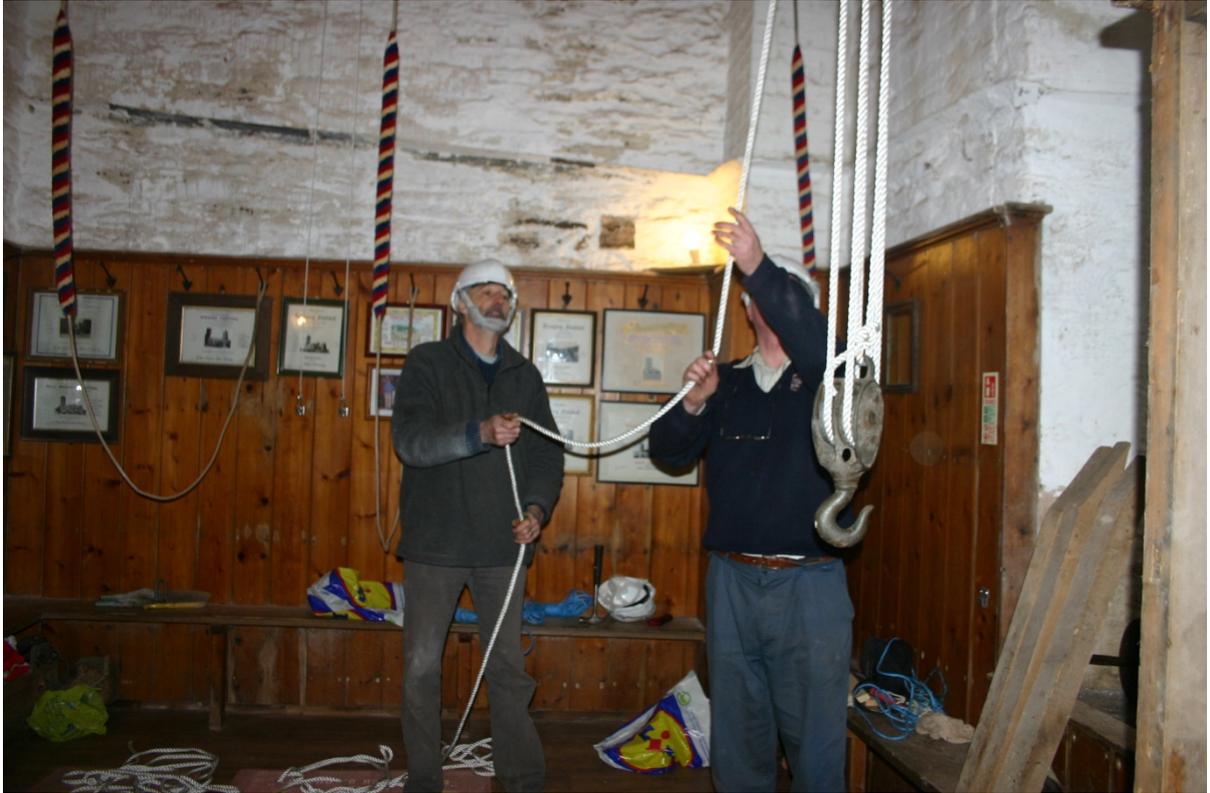
Unhanging the weights. January 2013.

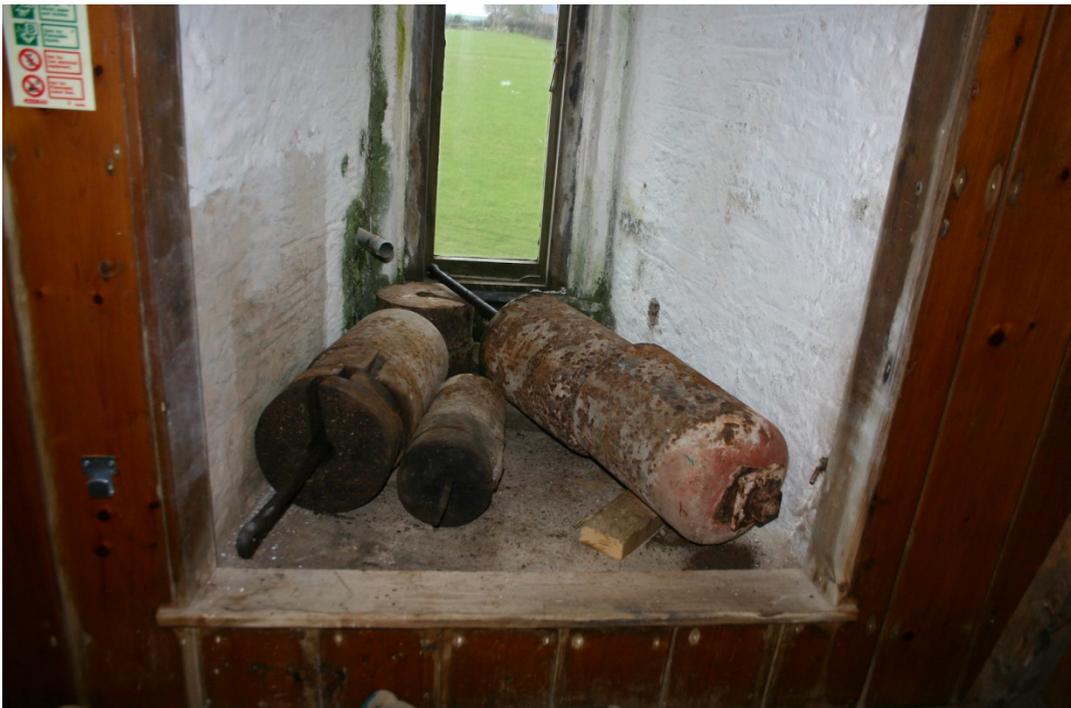
The clock weights temporarily stored on the windowsill in the ringing chamber in early 2013.
